Geomechanical model of the unstable part of the geological environment of the southern slope at the Gacko coal mine

Boško Vuković

*Department of Geology, Faculty of Mining/University of Banja Luka,
Bosnia and Herzegovina*

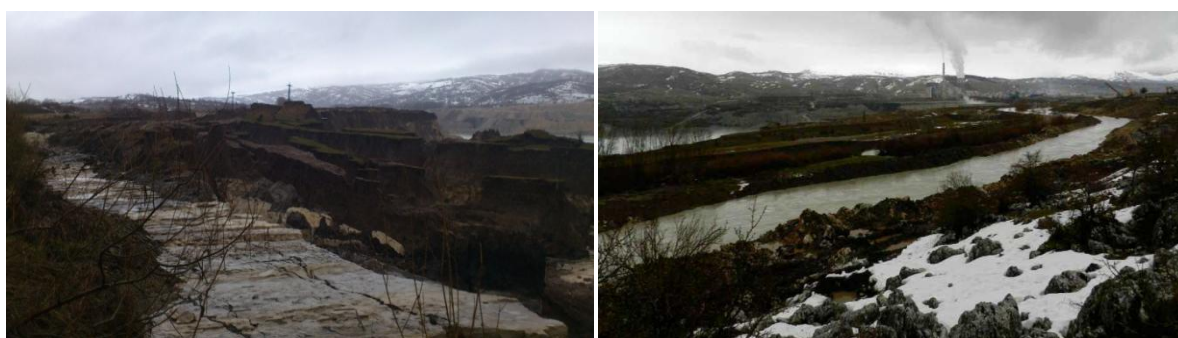
Considering the night conditions, the only thing that could be noticed was the work on the cracks on the asphalt road to the village of Srđeviče (in place of the existing cracks that were repaired by filling buffers). This phenomenon was mainly manifested in terms of the creation of gaping cracks and material sinking. No significant changes were observed in the part of the field between the road and the southwestern slope of the mine. Cracking was also registered in the pipeline for pumping out water and one metal "support" was bent. This was evidence of the existence of stress and displacement of the terrain. On March 9, 2013, around 7:15 a.m., water broke through the main protective embankment. In the period from 8:00 a.m. to 8:15 a.m., "bangs" were heard, probably caused by the flow of water into field "B" through the fracture zone. The sliding of material and the penetration of water from the river Mušnica into the surface mine occurred on March 9, 2013 at 8:15 a.m. The crash itself lasted about 10 seconds and was followed by a cloud of dust and fog. During the slide, the bed of the Mušnica river broke and water entered the mine. Due to the breaking of the Mušnica river bed, the Gojković stream also flooded in because the water from the Gojković stream was directed east through the Mušnica bed. Only a small amount of water flowed from the Gojković stream in the Srđević gorge. As the Gračanica river flows into the Mušnica before the place where the river bed broke, the Gračanica practically flowed into the surface mine. The sliding direction of the material was south-north, which could be seen from the material in field "B" before filling with water. The wider and narrower location of the landslide zone, the consequences caused by the landslide and the penetration of the Mušnica river (with Gračanica) and the Gojkovića stream into field "B" of PK "Gračanica" Gacko, are shown in Figures 1-4.

Pictures 1 and 2: Movement of blocks from the south side of the surface mine (zone of river penetration into the mine)

The first remedial measure, was to urgently prevent further inflow of water from the Mušnica river into the excavated area of the surface mine, which was done in the shortest possible time by excavating and relocating part of the Mušnica river bed (approx. 960 m long) to a stable part of the terrain and partially remediating the bottom of the Gojković bed streams in the most vulnerable places.

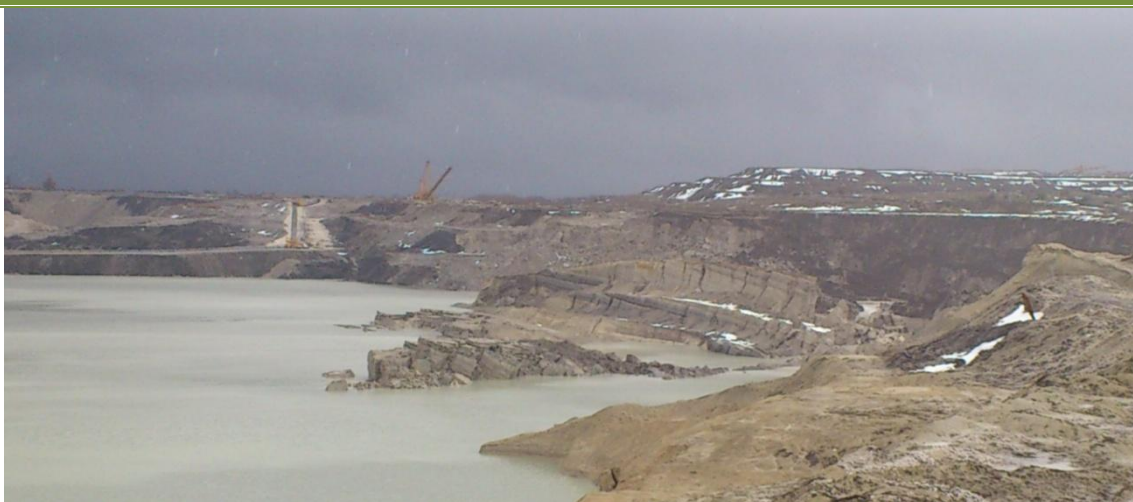
Figure 3: Launched marl blocks from the south side and the formation of an artificial accumulation in the Gacko coal mine

The third remedial measure, is to prevent further destabilization of the soil, i.e. sliding of the southern and southwestern slopes of the Gračanica Gacko surface mine, which would be carried out by "supporting the moving masses", i.e. by depositing overburden in the excavated area. It should be noted here that, before the penetration of water from the Mušnica River into field "B", this area was planned for the formation of an internal landfill and the disposal of a large part of overburden, interlayer tailings and selective tailings from field "C". However, the newly created situation has led to the fact that it is necessary to first drain the water from field "B", in order to free up the planned space for the formation of a landfill, as well as that the newly created situation requires faster disposal dynamics at the bottom of the mine, i.e. the very "subversion of the moving masses". as measures to rehabilitate this area.

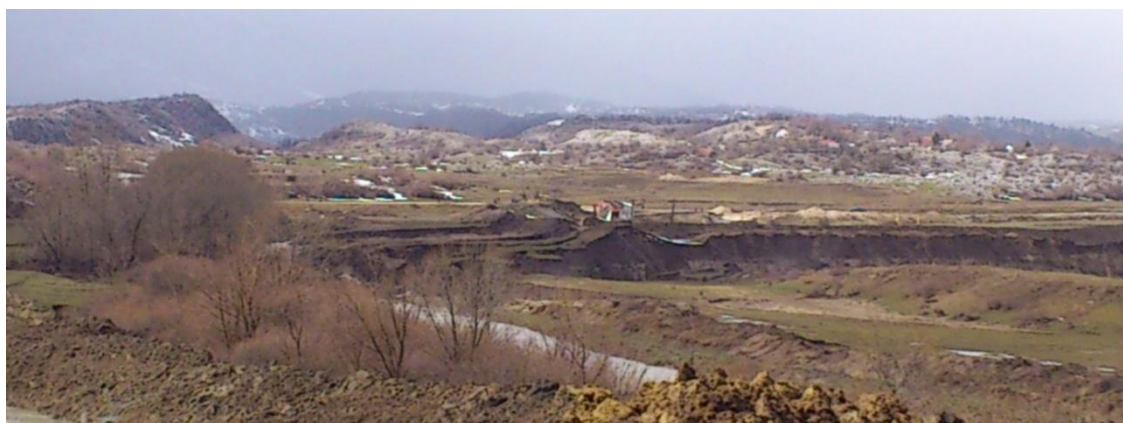
Figure 4: Landslide on the western side of the surface mine (Gojković stream zone)

The second rehabilitation measure, which was carried out in the summer of 2013, is the relocation and regulation of the Gojković stream bed, as well as the definitive arrangement of the relocated part of the Mušnica river bed, which will permanently protect the surface mine from possible intrusion of water from these streams.

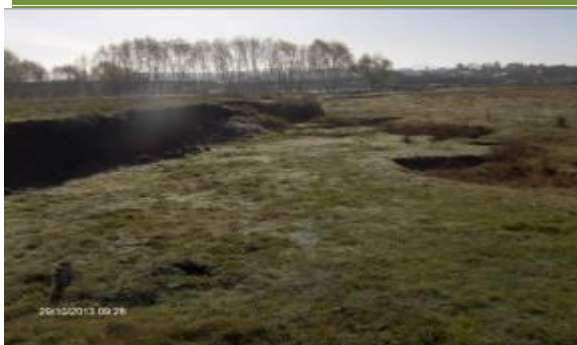
It includes the NW and SE part of the projected cross section 2-2'. The south-eastern border of this terrain ends about 150 m before the mouth of the Gojković stream in Mušnica. The western part of the terrain rests on Cretaceous sediments and immediately from the contact with them there are numerous discontinuities and ruptures that occur at a distance of less than 5 m. Numerous discontinuities and ruptures are present in the GM-1 exploratory well execution zone. Generally speaking, all discontinuities and ruptures have the direction of providing contact with Cretaceous sediments. Figure 6 shows the deformations on the ground in the area where the GM-1 exploratory well was executed.

Figure 6: Deformations on the ground

Some cracks in this part are continuously over 200 m long, up to 1.5 m wide and up to 2 m deep. It should be emphasized that in this part there was a gradual lowering of the terrain, that is, the subsidence of Quaternary formations, which can be seen in the mentioned picture [4]. Quaternary formations are of very low strength and are subject to erosion or washing away. During the execution of the exploratory well, in one of the cracks on the border of the Quaternary and the Neogene, a small amount of water was observed, which can be seen in Figure 7. In the immediate vicinity of the executed well GM-2, i.e. to the south of it, there are numerous cracks and subsidence terrain. 100% of the mud was lost during the entire time the mentioned borehole was being drilled, and at approximately 14 m of its depth, you can hear the seepage of water. Traces of movement in the Neogene sediments are visible on the core of the GM-1 borehole, and at the contact with the Cretaceous sediments, striae, i.e. traces of movement, are clearly visible, which indicates that the movement of sediments in this part occurred at the border with the limestones (base part) and directly above them. In case of unfavorable hydrological conditions and water penetration into the cracks, there is washing of the binder, movement and tearing of the blocks, so that the observed terrain can be moved in a short period of time, resulting in complete instability of the working slopes. In Figure 8, in one of the present cracks, the tearing of the blocks can be seen in the horizontal and vertical planes, and above the blocks, the soil in the quaternary deposits. In Figure 9, cracks and dredging on the slopes of the floors are shown[4].

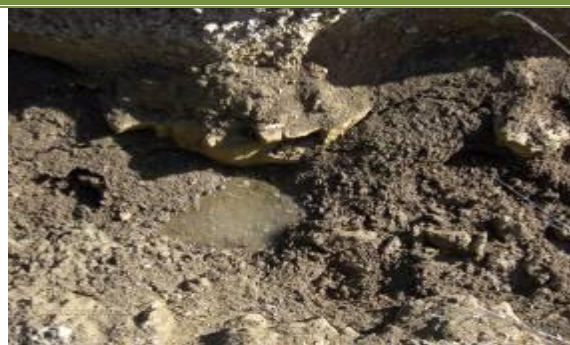
Figure 7: Spring of water at the border of Quaternary and Ng

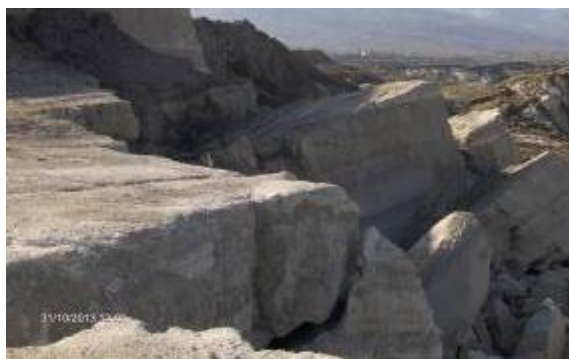
Figure 8: Tearing blocks

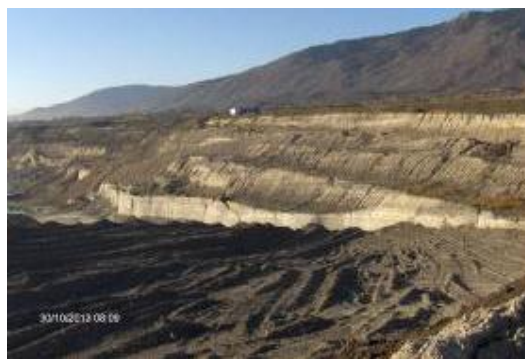
Figure 9: Dredging on slopes

In this zone of observation by the geodetic service, rappers have been placed on the observation of impaired stability. On the basis of the comparative displacements, millimeter to centimeter oscillation of the benchmark can be seen, which indicates that the process of moving the ground is still ongoing. The zone of unstable terrain covers the largest area of observed slopes of 0.28 km².

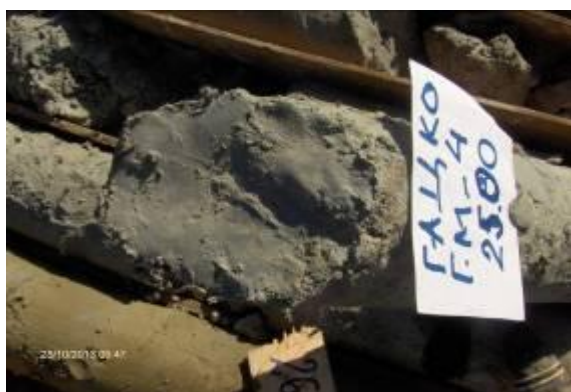
During the determination of the extracted core from the GM-3 and GM-4 wells, in several places in the Neogene sediments, fault mirrors, probably sliding legs (because they are hypsometrically in the lower levels of the swollen material, pictures 10 and 11), were found, which indicates to us that in in the previous period, the movement of these masses began, and with the appearance of several unfavorable factors, there was a slide. In Figure 11, the entrainment of the higher moving masses over the unmoved terrain is clearly visible. As in the zone of unstable terrain, in this part as well, the geodetic service of the mine and thermal power plant has set several reference points along the profile lines for observing disturbed stability. In the report dated 31.07.2013. years, the elevation of the ground on some rappers was recorded. These rapiers are located on the slope of the mine, just below the mouth of the Gojković stream in Mušnica and define a distance of about 50 m.

Figure 10: Sliding feet?

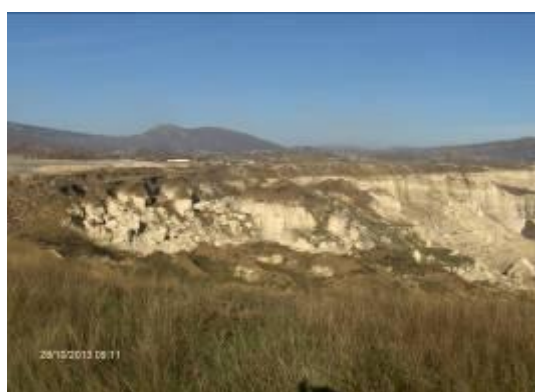
Figure 11: Pulling the moving masses

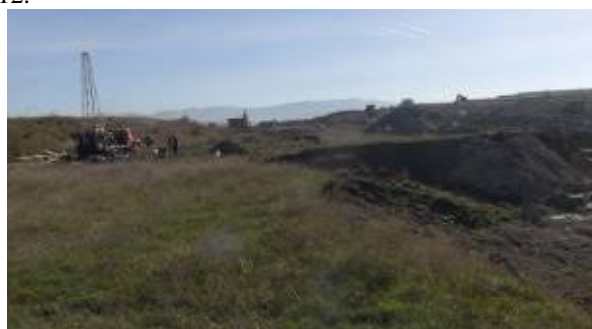
During the drilling of the GM-4 exploratory well, 100% of the water used for drilling was lost, and the terrain was affected by a series of cracks, and through one of them, the water came out on the slope of the floor (elevation 933), picture no. 12.

Figure 12: Discharge of water from the sloping floor

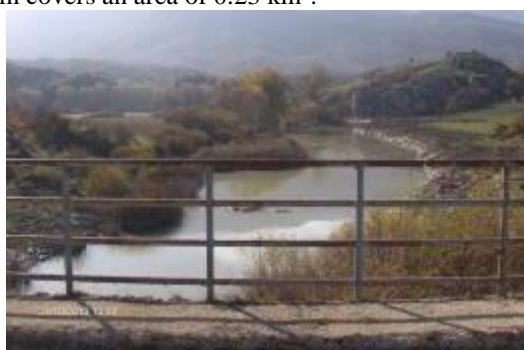
Figure 13: Plants downstream of the Mušnica River bed

In order to ensure an unimpeded flow of water, it is necessary to clear the Mušnica bed (downstream of the confluence with the Gojkovića stream) of vegetation and other vegetation (pictures 13 and 14). The high-risk terrain covers an area of 0.23 km².

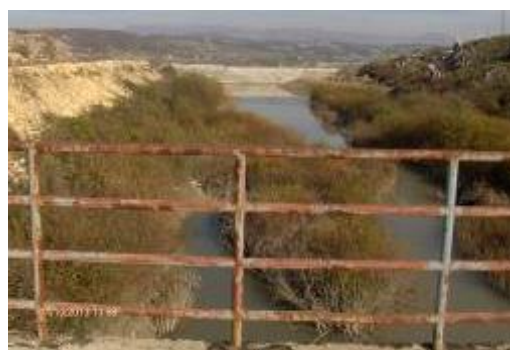
Figure 14: Plants upstream of the Mušnica river bed
