## Flexible Hose Lining Applies in the Complex Site of Extreme Long Length and Numerous Bends

**Abstract:** Trenchless technologies apply to potable water pipeline was introduced to Taiwan in 1996. Most of them provide various pipe rehabilitation solutions for water mains. However, rehabilitation of small and medium diameters has always problems to pipeline utilities. In 2017, ISO-11295 introduced a new technology called "Lining with inserted hose" (flexible hose Sliplining) provide a good solution for small and medium diameter rehabilitation Zhishan Road at Wai Shuangxi area in Shilin zone relies on the water supply from the Shuangxi Water Treatment Plant. Water source of Shuangxi is greatly affected by the dry season. Water supply jurisdiction lacks a backup mechanism, and the risk of water supply is relatively high. Therefore, to establish a backup water source for the Shuangxi Water Treatment Plant. Taipei Water Department intend to apply the water from the Huaxing Distributing Tank as the backup water source for the Shuangxi Water Treatment Plant. A 220mm diameter high-strength and flexible hose liner slip into the old Shuangxi raw water pipeline which path in the Jungle. Dep

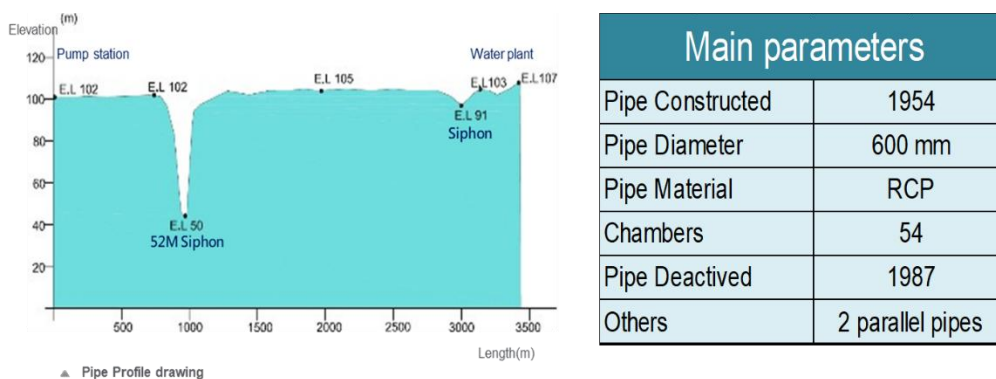
Fig. 2-1-2. Pipeline profile and information

The construction scope of Shuangxi Water Treatment Plant Backup Water Supply Pipe Turnkey Project required insertion a pipe which diameter should be over 220mm into the old pipeline comprised two parallel  $\phi$  600-mm reinforced concrete pipes (RCPs). Total insertion length is about 2,900M, plus open cut 120M to bury 300mm DIP at the middle cut-off section. The elevation of the entire line is gentle flat, but curvedly, except two inverted siphon sections with elevation differences, behind the National Palace Museum (up to 52 meters in elevation), and Jingque Stream (See fig.1.1)The raw water pipes were deployed on the multiple bends hillside. Due to the complex terrain, Only two access can carry tools and handy machine by man power. the deployment of large engineering equipment was difficult. Consequently, the project is more challenging than laying pipes in urban area. In this case, the contractor was responsible for reconnoitering the site and developing construction plans. (Figs. 2-1 -1& 2-1-2).

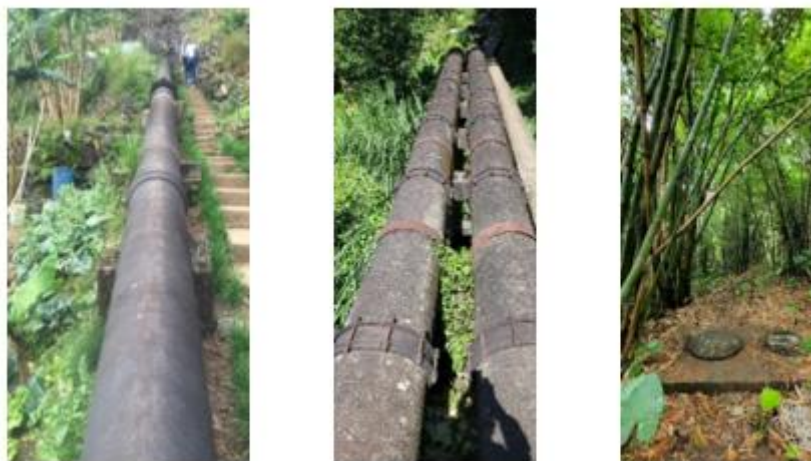
Fig. 2-1-3. Photos of  $\varnothing$  700-mm cast iron pipe, parallel  $\varnothing$  600-mm reinforced concrete pipes, and manholes

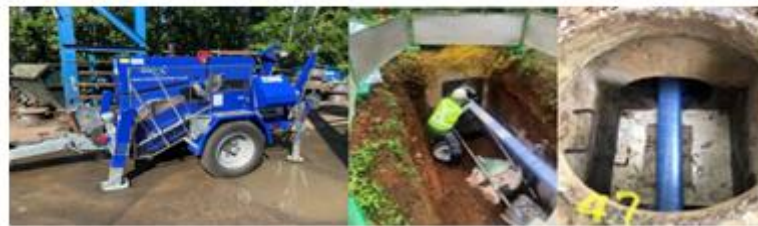
Fig.2.3 10-ton pulling winch and liner insertion

The system supplier calculated maximum pulling force is 6.1 tons initially based on 0.5 friction coefficient and 1.3 safety factors. Therefore, a 10-ton pulling winch was arranged to meets the pulling force requirements. Wiping vegetable oil on the fold liner as lubrication material is necessary to reduce friction (Fig. 2.3) .

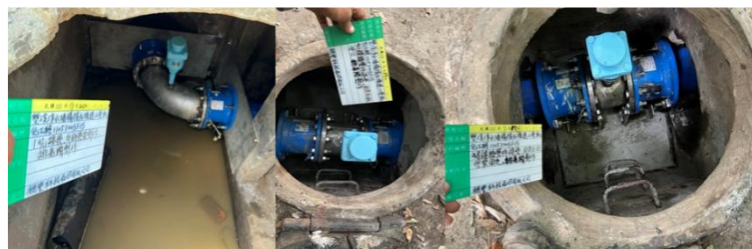
Fig. 2-4-3. Short stainless-steel tube mounted to steel plates on manhole walls.

Connectors are specially developed termination fittings which was bolt-connected to the flexible liner with connectors and mounted on the walls of a manhole chamber (Figs. 2-4-1 2-4-2 &2-4-3).

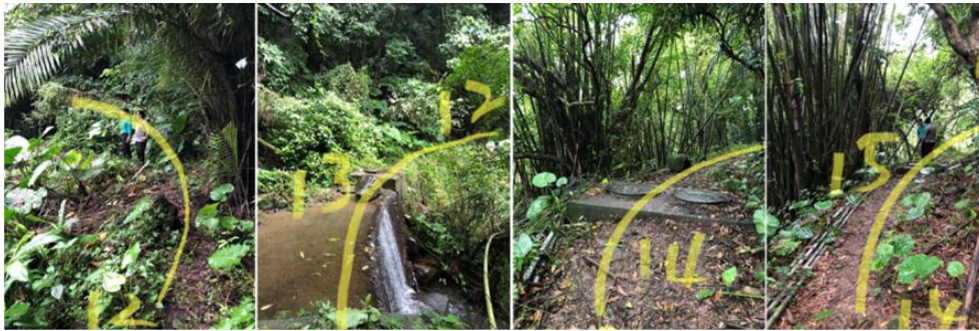
Fig. 3-1-2. Analysis of on-site pipe curvature.

Liner weigh is 4 kg/m. In section 1, Initially pulling force was estimated at 6.1 tons, but overlooked challenges such as mountainous terrain and curved pipes. The concrete raw water pipeline was buried along the curved of the mountain edge that created hundreds of bends, also chambers connected to the existed pipeline has a great curvature change (See fig 3-1-1 & 3-1-2) . A site inspection revealed the presence of 93 bends and 25 manhole sites with a significant height difference. Given these factors, a pulling force of over 16 tons was required.

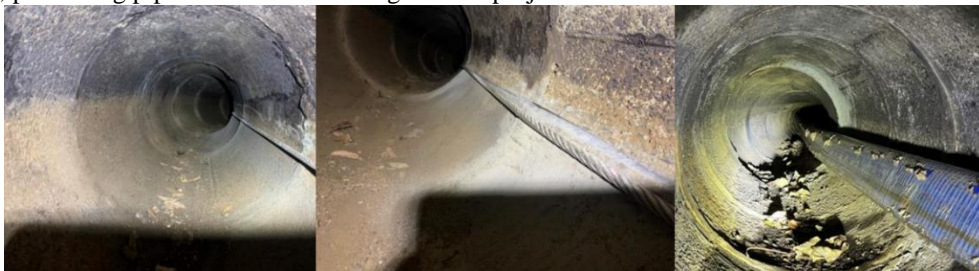
Fig. 3-1-3. Numerous bends cause slot on the RCP and scrap liner

When a pipe is pulled over a long distance, it would experience scraping against uneven concrete surfaces and cause the cable block in the slot. Also this scraping causes considerable damage to the liner. Therefore, preventing pipe wear was a challenge in this project.

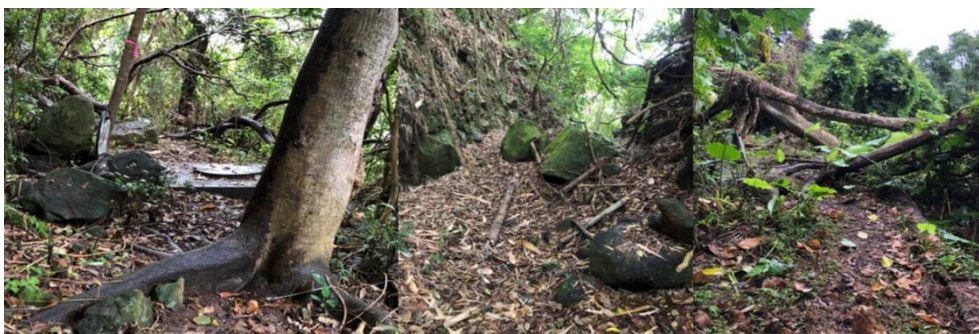
Fig. 3-2-1. Complex Terrain

The whole existed pipeline was located on the hillside, and heavy machinery cannot reach. Four 45° elbows located at two fixed blocks at the both sides of middle of the inverted siphon behind the hill of National Palace Museum caused the extra tensile load that did not expect from beginning. (Fig.3-2-1&3-2-2)

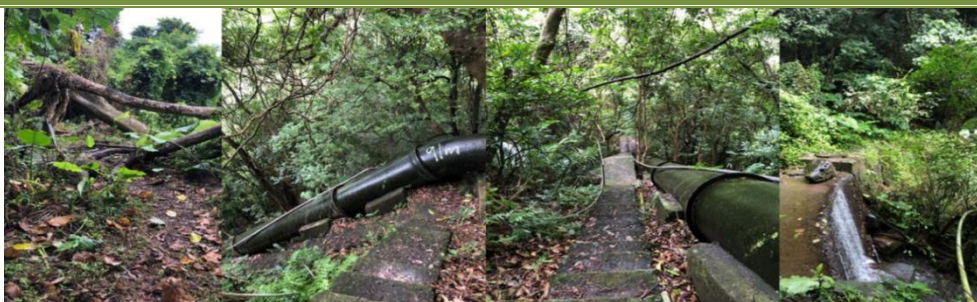
Fig. 3-2-2.4 extra 45° elbows at the siphon caused extra tensile load

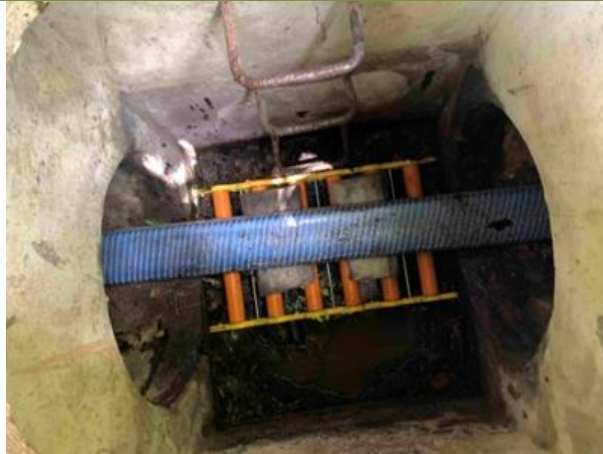
Fig. 3-3-2. Roller sets installed on the floor of manhole chambers

- (1) Rollers mounted on arch brackets (Fig. 3-3-1) were installed on the sidewall of manhole chambers to prevent the liner from scraping against the inner surface of the old pipeline.
- (2) Roller sets (Fig. 3-3-2) were installed on the floor of manhole chambers to reduce the contact between the liner and the old pipeline.
- (3) Rollers lined up in a curve (Fig. 3-3-3) were installed on the sidewall of manhole chambers to allow the line to pass a bend with minimum friction.

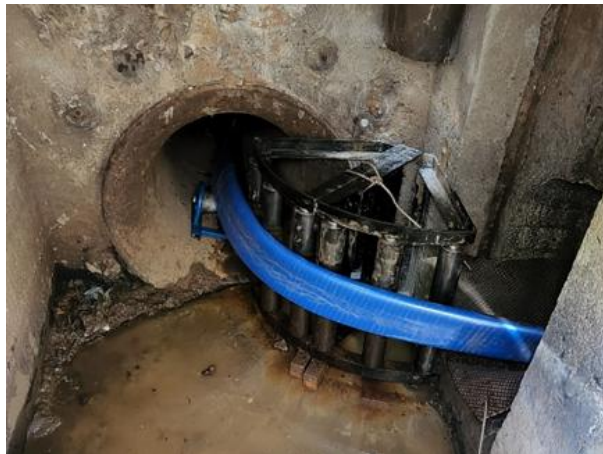
Fig. 3-3-3. Roller set comprising rollers lined up in a curve.

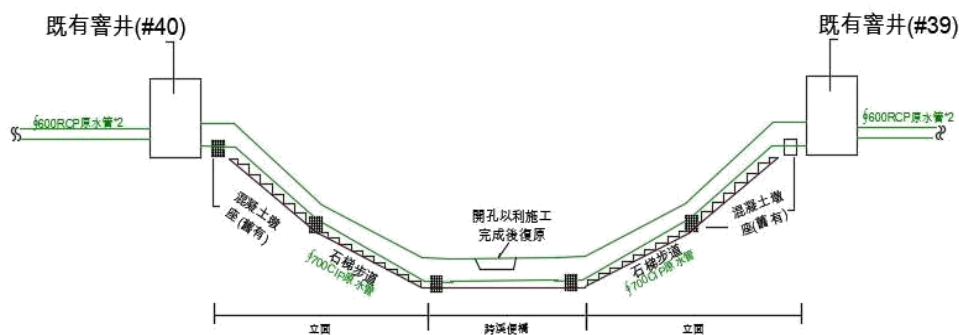
Fig 3-3-6. Extra rollers in inverted siphon pipes

In the manholes, a  $\phi$  300mm duct tube was installed to provide support to the liner pipe, thereby allowing the liner to enter the  $\phi$  700mm CIP at a 45° downward angle (Fig. 3-3-5 & 3-3-6).

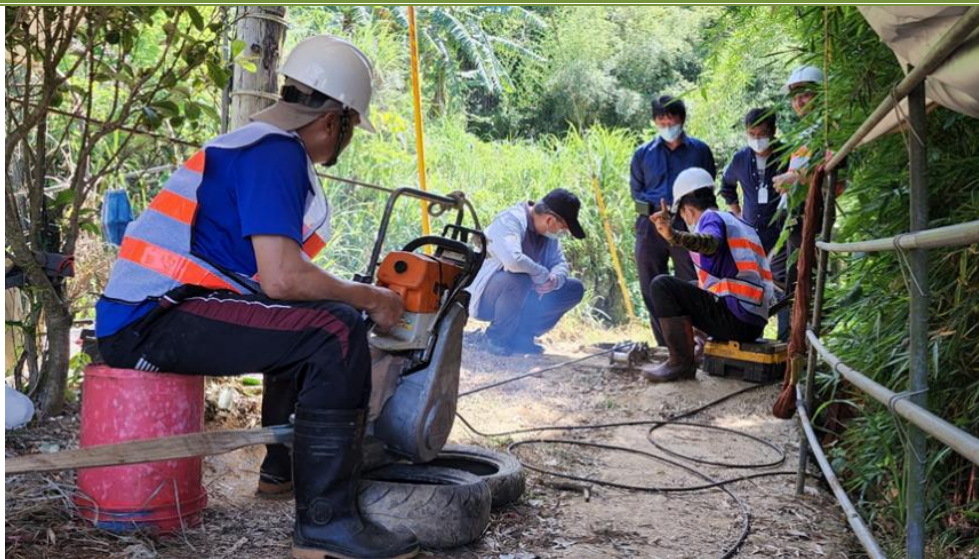
Fig. 3-3-7. Small portable winch used as an auxiliary winch.

Applied portable winch at the several S cures points of chambers, and synchronous pull to provides auxiliary pulling force to release the stuck points. Finally, the main winch completes the task with a pulling force less than five ton (Fig. 3-3-7).
